# Characterization of joint mortars and pavements from the Roman site of A Ciadella (NW Spain)

## Caracterización de morteros de junta y pavimentos del sitio romano de A Ciadella (NO de España)

Enrique M. ALONSO-VILLAR<sup>1</sup>, Teresa RIVAS<sup>1\*</sup>, Adolfo FERNÁNDEZ<sup>2</sup>, Marta LAGO<sup>2</sup>, Alba RODRÍGUEZ<sup>2</sup>, Patricia VALLE<sup>2</sup>

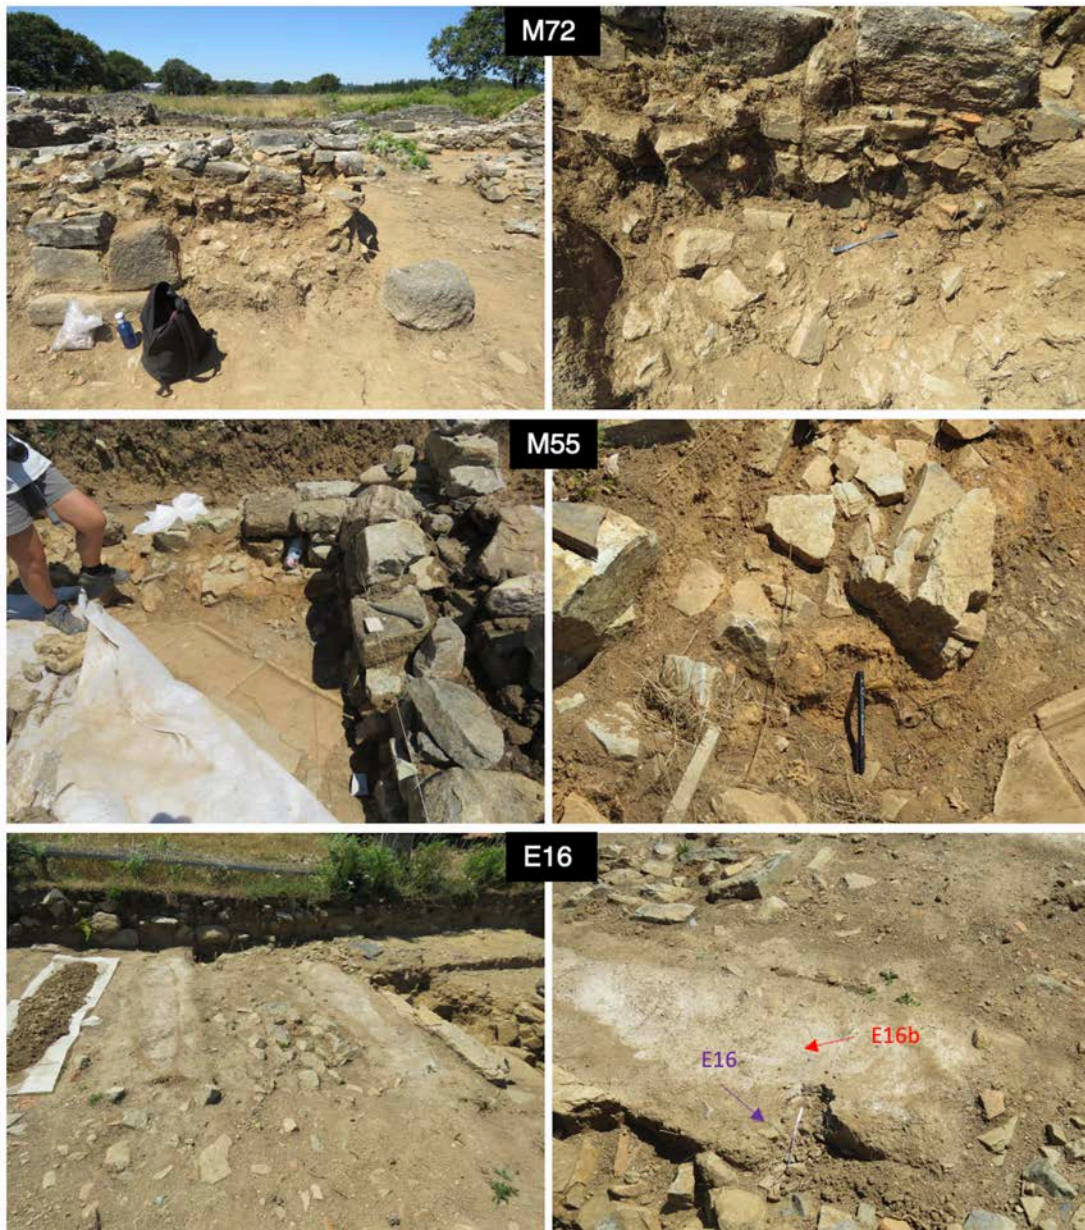
Figure 2b (cont.): Location and detail of mortar samples of joints M72 and M55 and pavement E16. The tip of the spatula identifies the sampling point. A detail of the surface of pavement E16 is also shown, which makes it possible to distinguish the more whitish color that affects the most superficial 2 cm (where sample E16b was collected) in contrast to the rest of the pavement, which has a more reddish color.

Figure 1 depicts the map of the archaeological site with the location of the samples; Figures 2 and 2 (cont.) include images of the collected samples and their location.

- M55: granular structure and weak degree of development; color 10 YR 5/6
- E16: earth pavement with granular structure and weak degree of development; color 10 YR 7/3. Its general color is brownish-yellowish but a local whitish coloration (10YR 8/2) is observed affecting an area of 100 cm × 45 cm and only up to 2 cm deep from the surface (Fig. 1 cont.); in some points, the limit between the whitish zone and the earthy material is diffuse; in others, however, the limit is net. A sample

of the earthy material (E16) and the material affected by the whitish coloration (E16b) was collected in this pavement.
