# The parish church of San José in Montealto (1960-68). A critical review

Esteban Fernández-Cobián · University of A Coruña (UDC) · efcobian@udc.es

Rafael Pazos Ansón · Independent Researcher · raindrop-close2u@hotmail.com

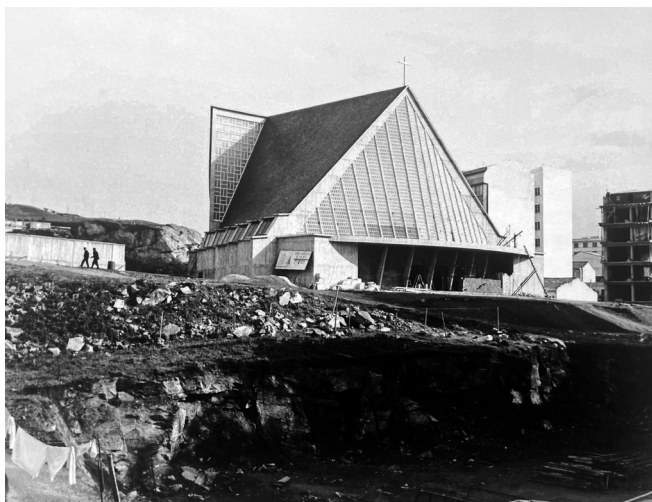
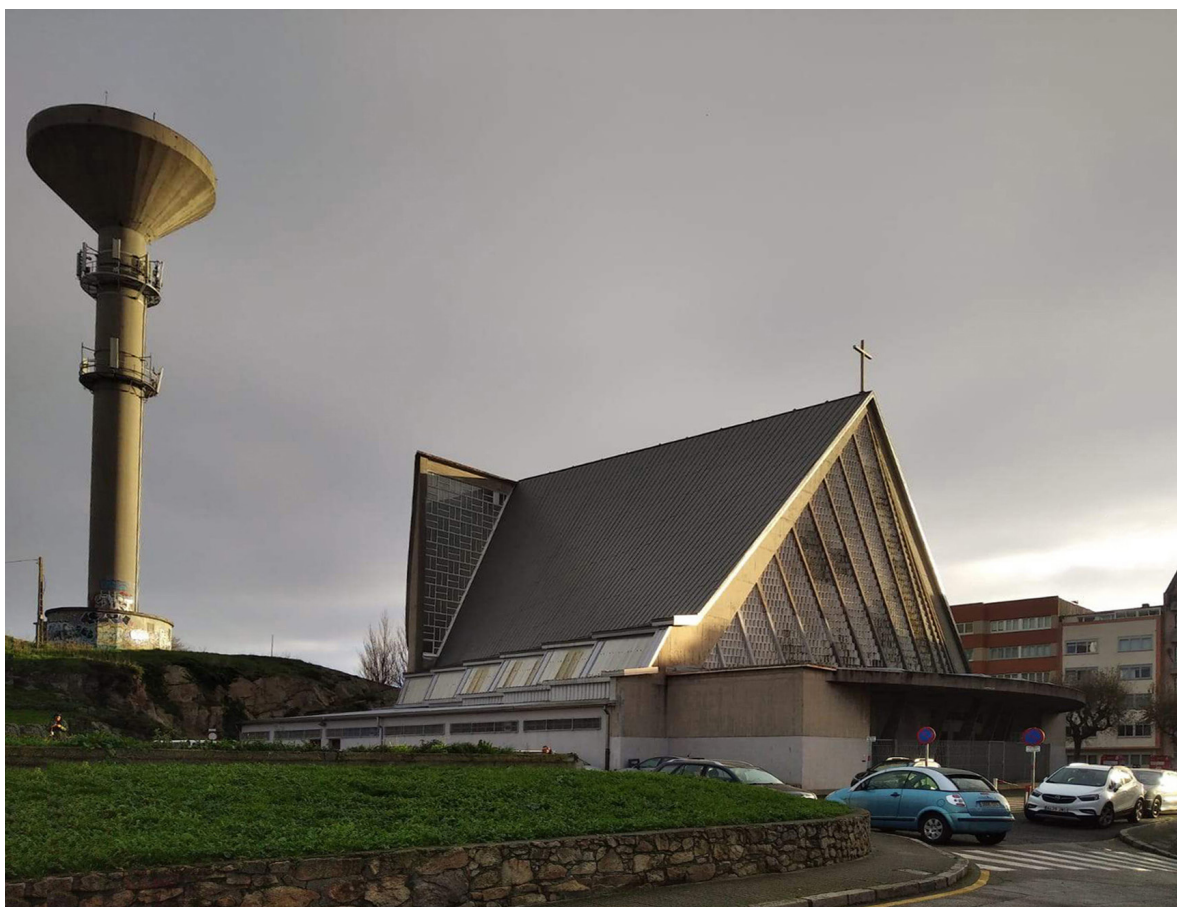
Fig. 11. Jacobo Rodríguez-Losada Trúlock, parish church of San José, A Coruña, 1960-68; the facade and the presbytery at the end of the works.

Fig. 12. The facade today.

The interior space is the result of the juxtaposition of two distinct elements: the nave and the presbytery. The lines of force of the triangular nave converge in the presbytery, an autonomous volume enclosed by a parabolic end wall and covered by a reinforced concrete slab with a catenary cross-section. (Fig. 11) The dark stone that forms the altar table—from a quarry located on Mount Oural, in Lugo (Lamas 2000)—rests on a large rock with carvings found in the same place where it is currently located.<sup>12</sup>

According to the parish priest's account (and perhaps as a result of his conversations with the architect), the building's form symbolically links certain religious concepts with those related to popular culture. Thus, the Holy Trinity is represented in the triangular shape of the façade, the church's nave has nautical references, adopting the shape of an inverted ship's keel, and the apse alludes to the biblical tent of meeting, whose stained-glass windows provide a diffuse, *Sinaitic illumination* (Lamas 2000). (Fig. 12)

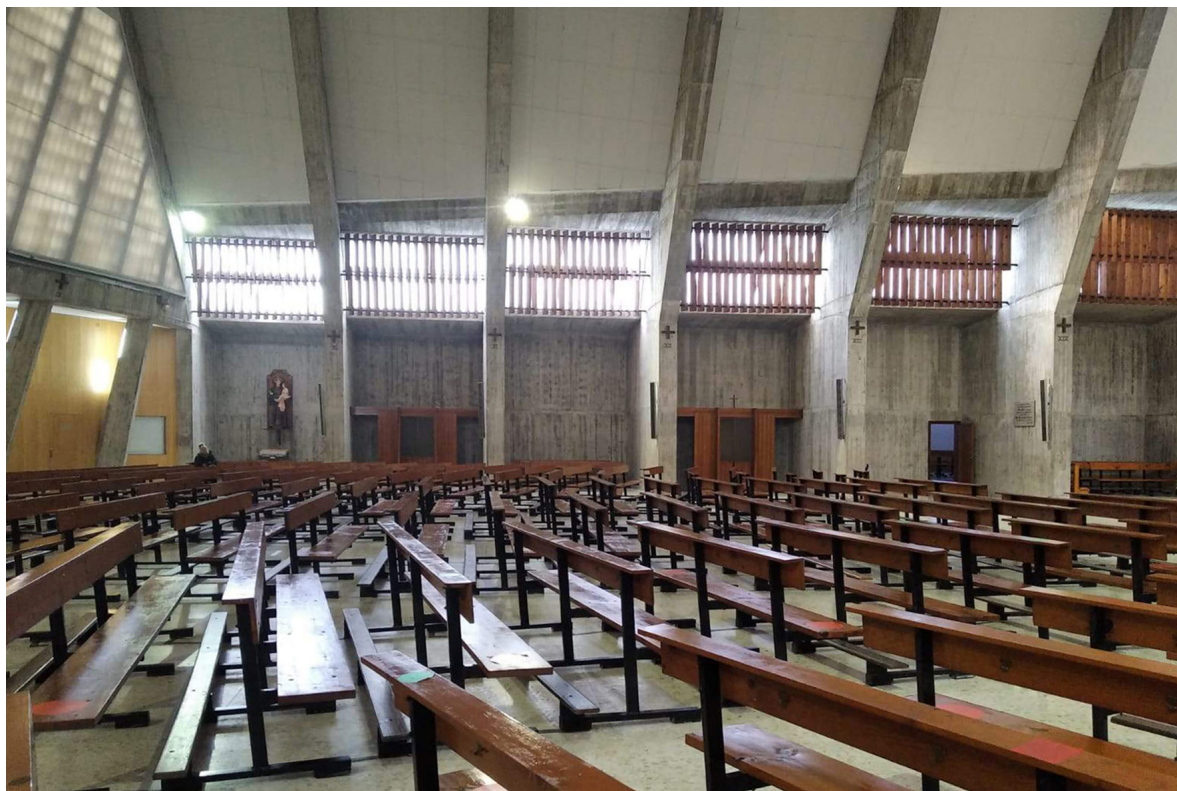
Fig. 13. Jacobo Rodríguez-Losada Trúlock, parish church of San José, A Coruña, 1960-68; detail of the nave.

In reality, the Church of San José displays another, deeper kind of symbolism, one that the parish priest himself would explain in his 1968 writing. Its size and elevated position make it an urban landmark and a monument dedicated to God. Its form and scale are recognized as such by the collective subconscious, even though a 4.5-meter-high stainless steel cross crowns the façade. And its vertical interior *is filled with light and air*, inviting one to look upwards. (Fig. 13)

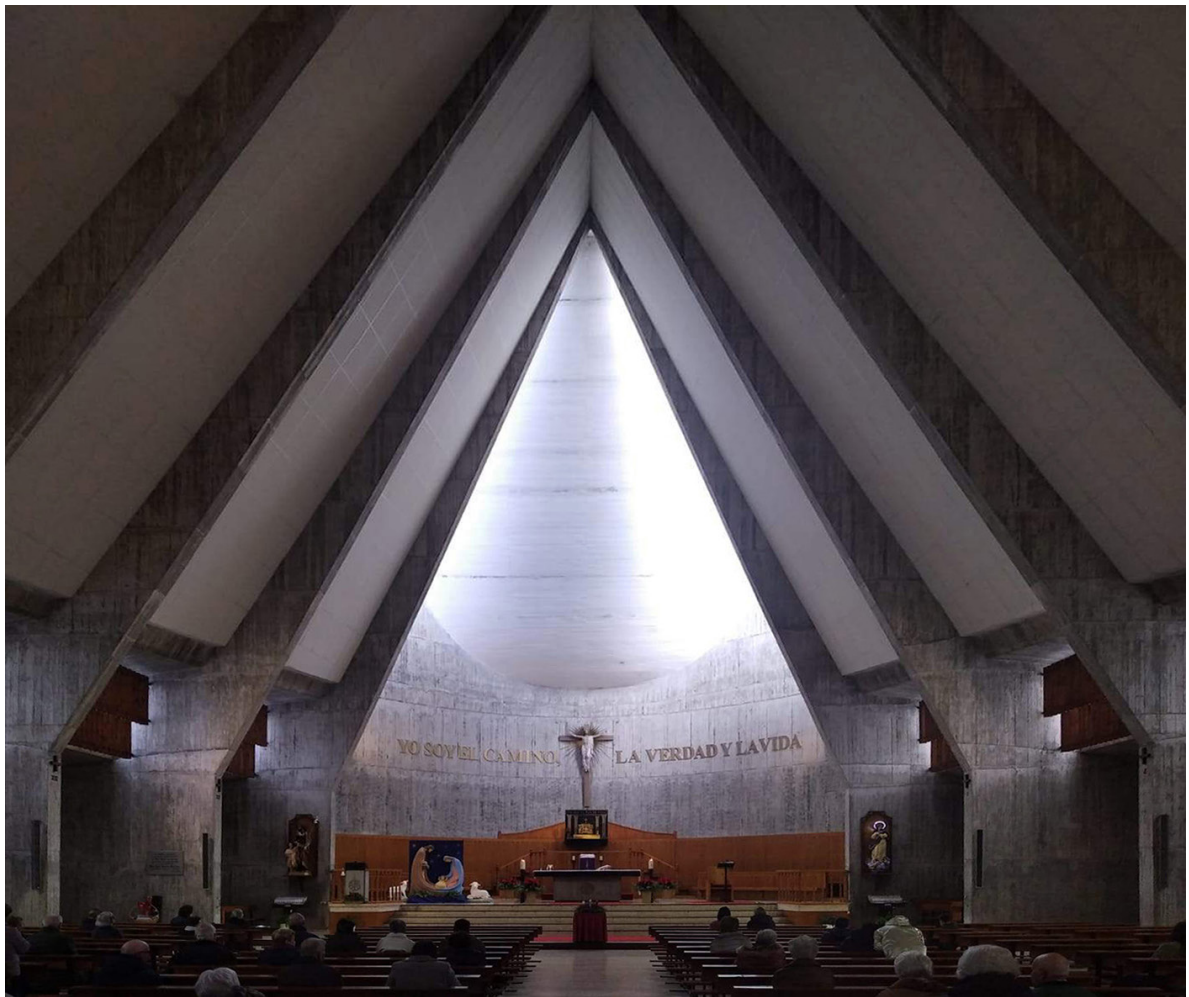
Fig. 16. Jacobo Rodríguez-Losada Trúlock, parish church of San José, A Coruña, 1960-68; the structure.

By making optimal use of the possibilities of reinforced concrete —1,300 m<sup>3</sup> of concrete and 50 tons of iron were used in the structure—, the architect managed to combine a large capacity with good visibility conditions, making it possible for the faithful to be close to the altar, which was one of the objectives of the Second Vatican Council. In fact, between the 1964 project—which still depicted the priest officiating with his back to the congregation—and the 1968 project—where the priest now faces the congregation—several important liturgical documents were published, including the controversial instruction *Inter Oecumenici*, dated

succession of pointed porticoes that decrease in width as they progress—has managed to maintain the courtly character of the space. (Fig. 16)
