Disasters, Memory and Liturgy. Liturgical Spaces in the Reconstruction Process of Historical Churches Damaged by Earthquakes

Giulia De Lucia· Politecnico di Torino (Turin, Italy), giulia.delucia@polito.it

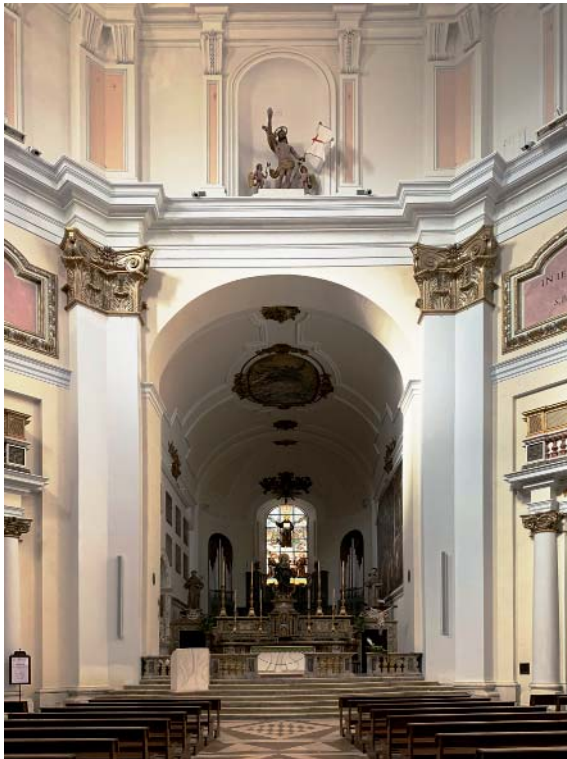
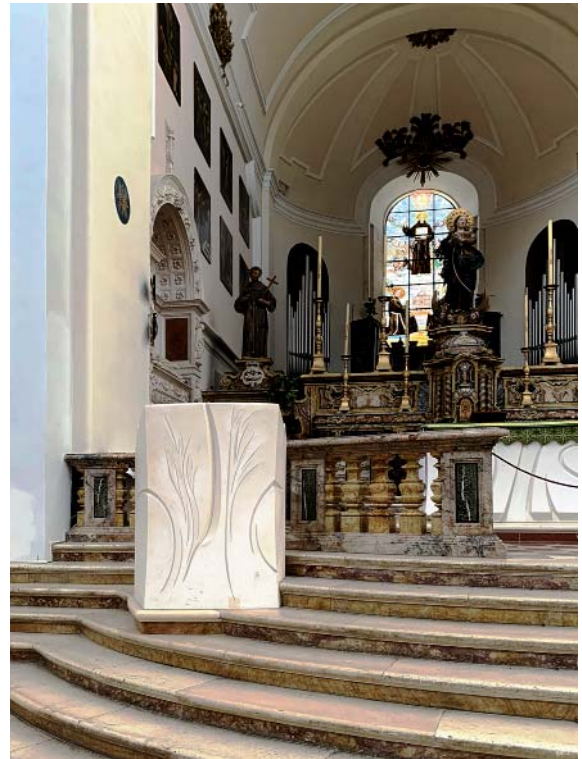
Fig. 10-11. Basilica di San Bernardino, L'Aquila (Italy), 2019; liturgical reordering.

restore interventions. A liturgical reordering was then applied (Fig. 10-11). The nun architect Michelangela Ballan designed it. Surely, the most distinctive feature of this liturgical reordering is the insertion of white marmoreal blocks for the altar and the ambo. The aim is to resume the traditional white local stone. However, the opera is deliberately in dissonance with the rest of the church in order to diversify new and old elements. The liturgical reordering entailed a new altar in substitution to the oldest, a '70s wood altar without particular artistic relevance, and a new ambo, placed after the balustrade, on the presbytery steps. The intervention is entirely reversible, including the marmoreal addition to the presbytery steps that is removable. However, due to the marked difference between the new intervention and the baroque deco-

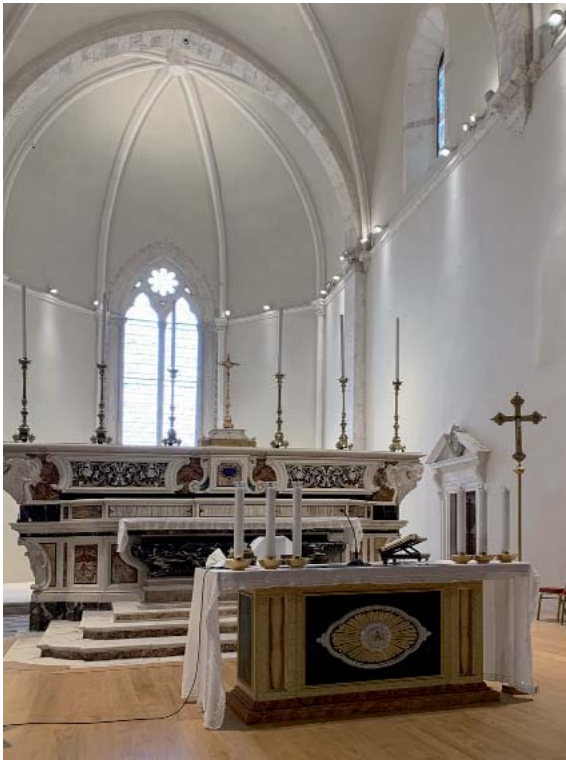
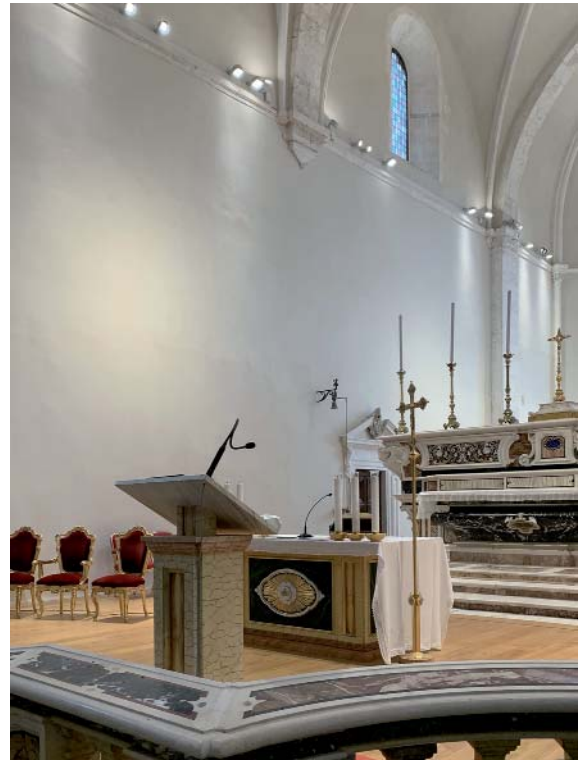
Fig. 12-13. Basilica di Santa Maria di Collemaggio, L'Aquila (Italy), 2019; after the restoration.

Fig. 14. Basilica di Santa Maria di Collemaggio, L'Aquila (Italy), 2019; after the restoration.

—The Basilica di Santa Maria di Collemaggio is one of the most relevant churches in the city. It was severely damaged by the 2009 earthquake: the transept vaults, the triumphal arch and the dome-drum system collapsed, and serious damaged were detected in the presbytery area. In this church, the restoration works have been very considerable (with an estimated cost of more than Euro 15 mln) with a courageous decision to entirely remove the baroque interior decoration, radically changing the stylistic configuration of the church, restored in its medieval features. Nevertheless, the great restoration has not considered for a liturgical reordering and the presbytery has been substantially untouched (Fig. 12-14).
